JEFFERSON PROVING GROUND  
SOUTH OF THE FIRING LINE

FINAL TECHNICAL PLAN

Jefferson Proving Ground  
South of the Firing Line  
RI/FS Technical Plan  
Volume I

September 1992

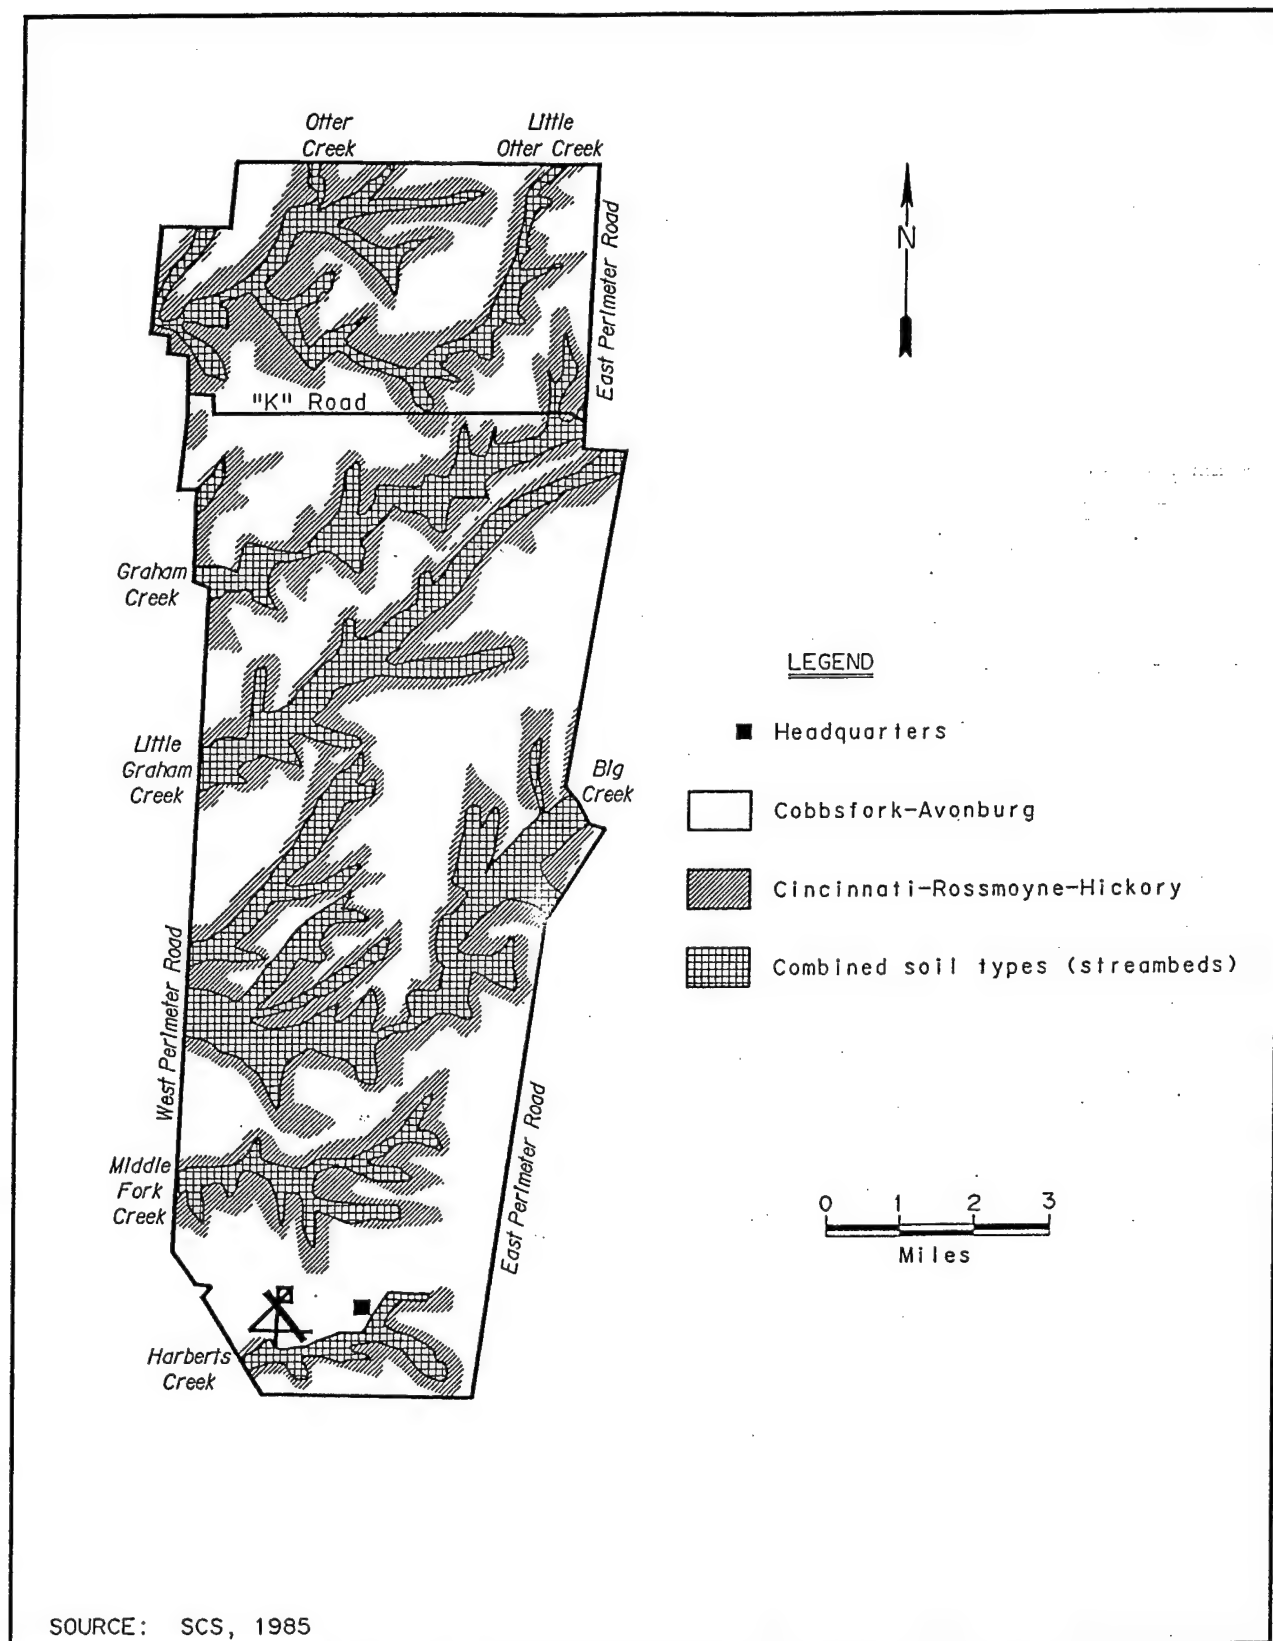
Figure 4. Soil Associations of Jefferson Proving Ground

Surficial deposits consist of glacially derived soils over glacial till of Illinoian and Wisconsinan Age and are characterized by silts and clays with only minor amounts of gravel and rock fragments. The two major soil associations present at JPG are the Cincinnati-Rossmoyne-Hickory and the Avonburg-Clermont. The Cincinnati-Rossmoyne-Hickory soils are generally deep, moderately well to well drained, whereas the Clermont-Avonburg soils are somewhat poorly drained. The Cincinnati-Rossmoyne-Hickory soils are found mainly on ridgetops, breaks, and hillsides at JPG. The Clermont-Avonburg soils are gently sloping soils located on broad ridges. Both associations contain fragipan layers (low permeability, firm and brittle) which restrict the downward movement of water. A combination of different soil types occur on or adjacent to stream beds. These soils include Ryker, Grayford, Holton, Eden, Elkinsville, and Wirt soil types. The soil types at JPG are summarized in Table 3 and are shown in Figure 4. The underlying unconsolidated glacial tills are typically 25 to 30 feet thick, but are generally absent in the stream valleys at JPG.

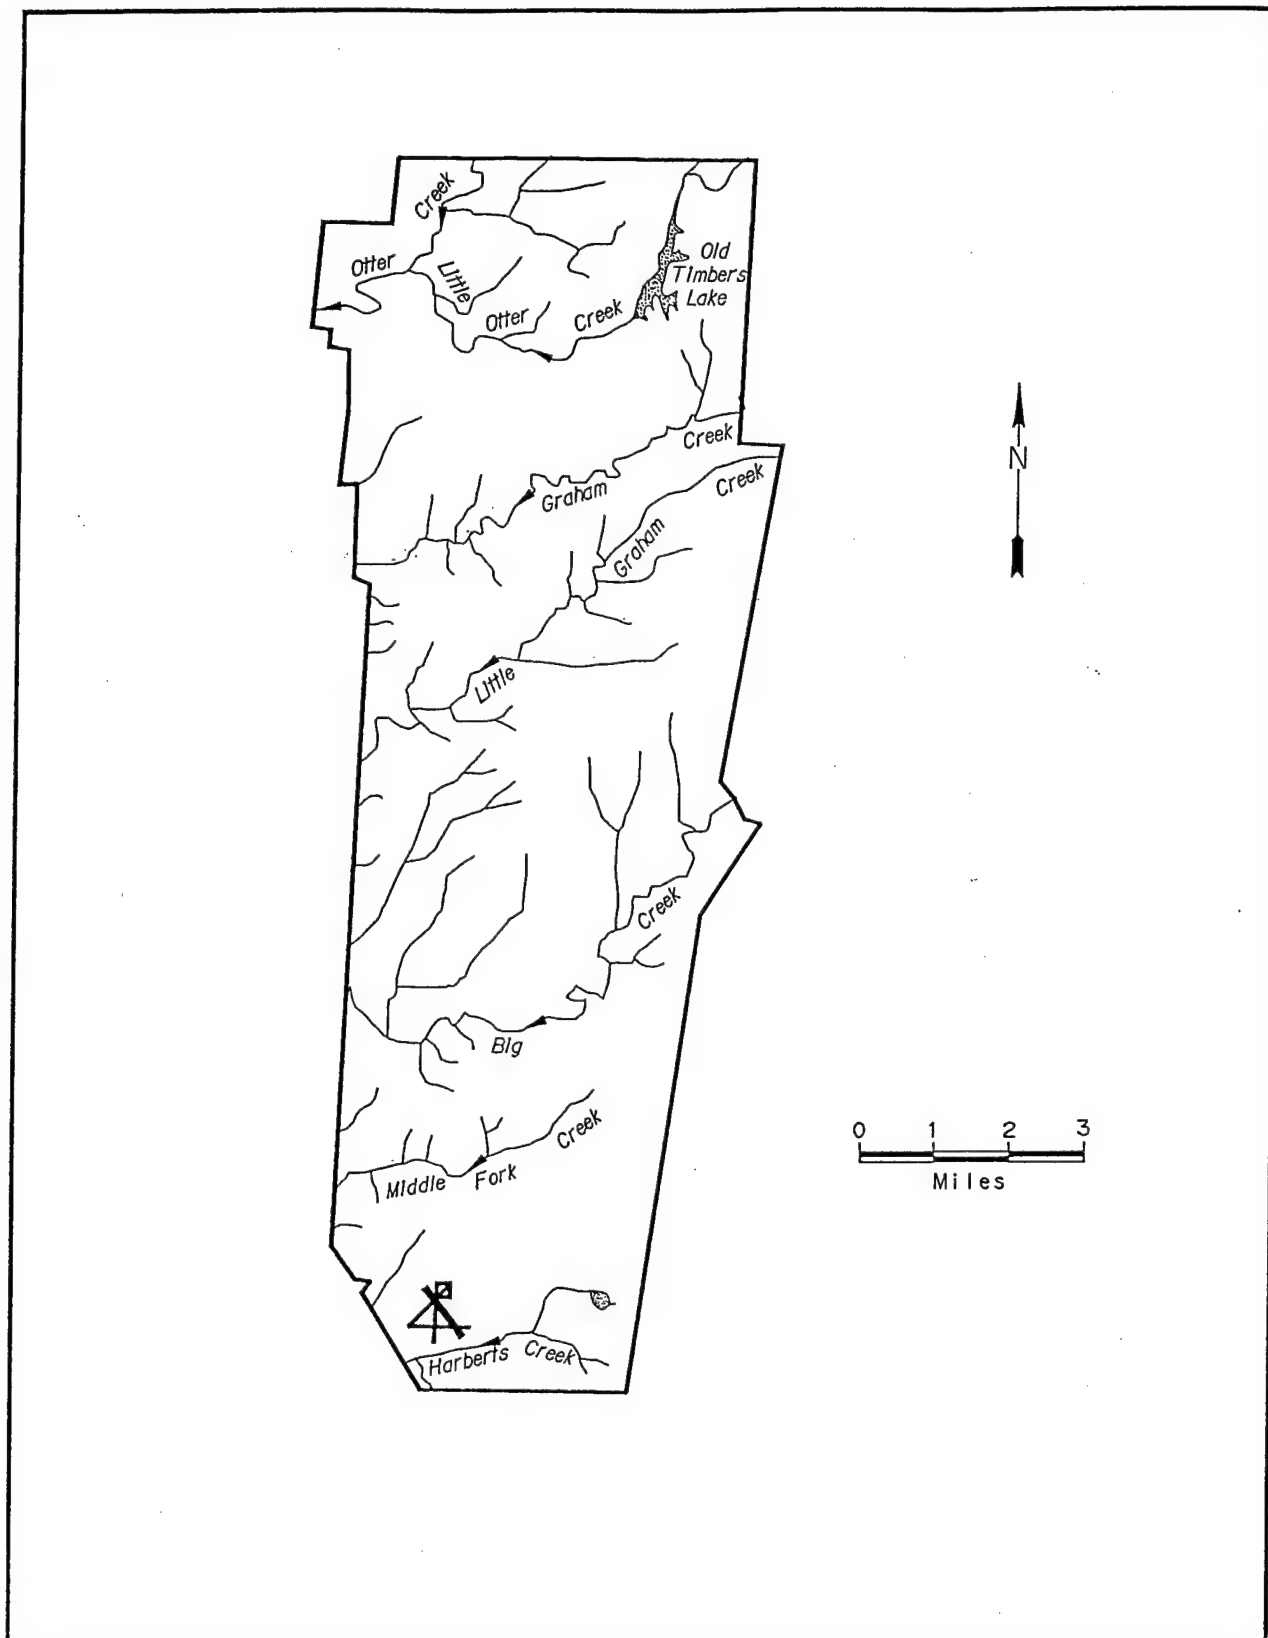
Figure 5. Stream Drainages at Jefferson Proving Ground

Surface water at JPG flows in several northeast-to-southwest-trending stream drainages across JPG toward the Ohio River. These drainages appear to have developed along major fracture lineaments (Greeman 1981). There are also at least 10 ponds on the facility (most of which are stocked with fish and used for recreational purposes). Figure 5 shows the major stream drainages at JPG.

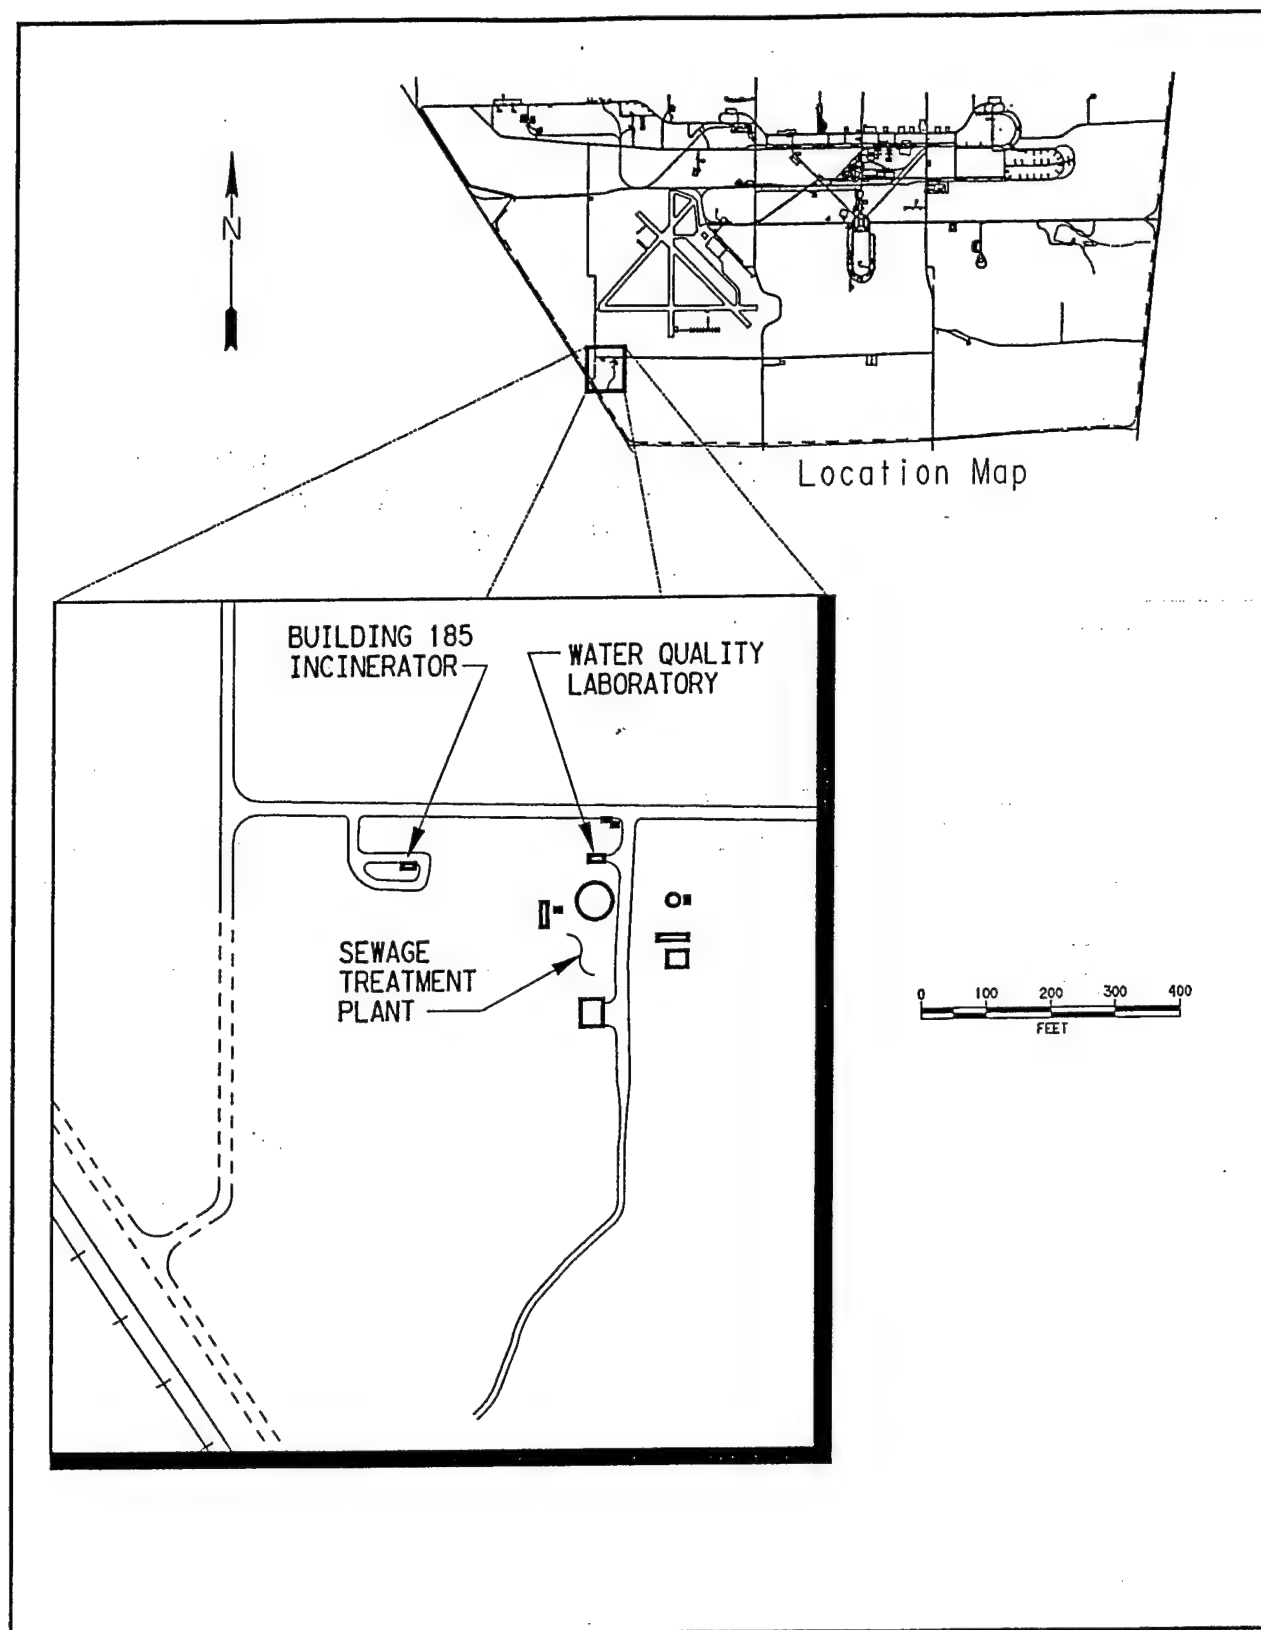
*Figure 6. Location of Building 185 Incinerator, Water Quality Laboratory, and Sewage Treatment Plant*

The Building 185 incinerator (see Figure 6) consists of a Morse-Bouler, single-chamber, single-burner, single-stack incinerator without an afterburner unit. The incinerator was used

The Water Quality Laboratory has been used for testing water quality at the sewage-treatment plant since the 1960s. The laboratory, located on the first floor of Building 177 (see Figure 6), generates small quantities of spent chemicals from conducting laboratory analyses. In the past, some of the chemicals appear to have been improperly disposed. Currently, however, chemicals from the laboratory are being properly stored, handled, and disposed of according to revised standard operating procedures. The exact nature and quantity of chemicals released to the environment in the past are unknown. However, the amount of spent chemicals generated during laboratory analyses is thought to be small.

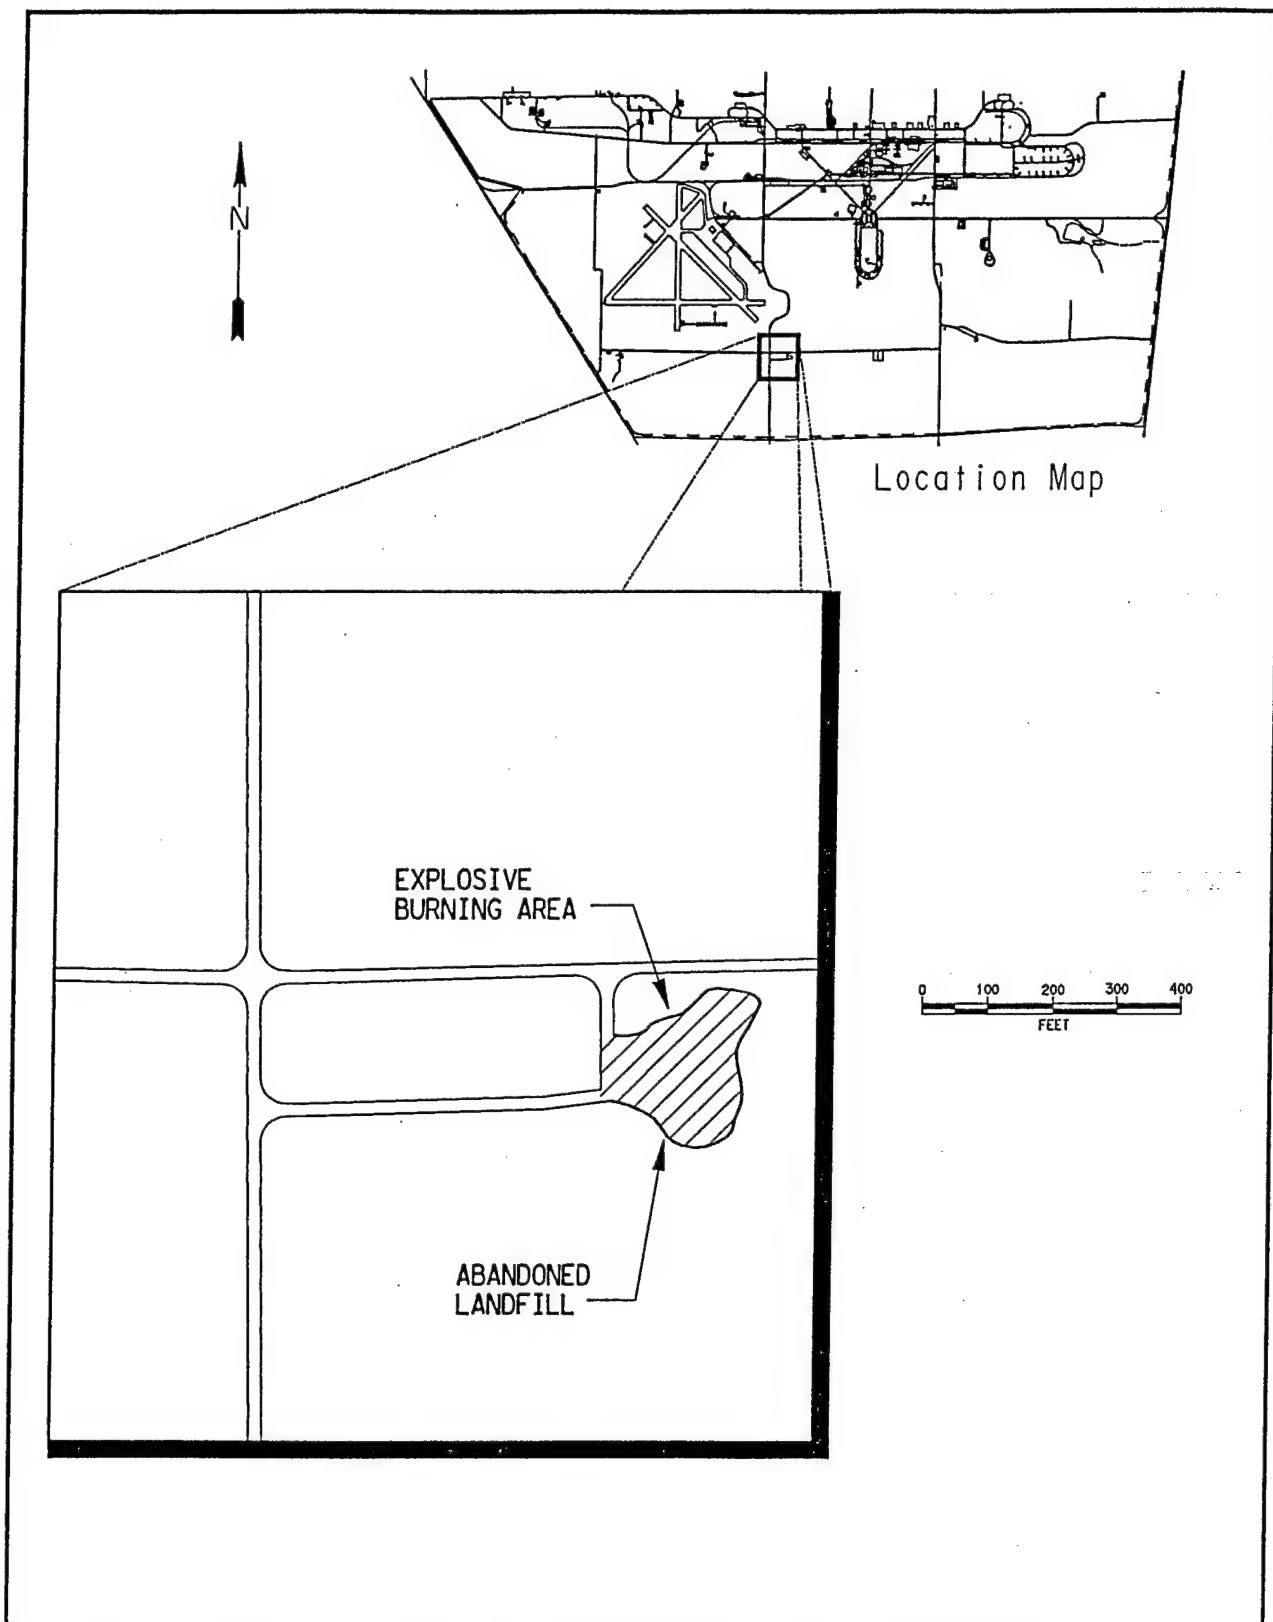
*Figure 7. Location of the Explosives Burn Area and the Abandoned Landfill*

The southern landfill, located just south of Engineers Road and east of Paper Mill Road (see Figure 7) consists of a one-acre landfill, which was used from 1941 to 1970 primarily as a dumping ground for film refuse from the photographic laboratory. In addition, spent solvents and red lead were also reportedly disposed of in this area. No records were maintained of the materials disposed of in the landfill. Currently, the area is totally overgrown with vegetation and is barely discernable. The landfill was described as being comprised of filled-in trenches.

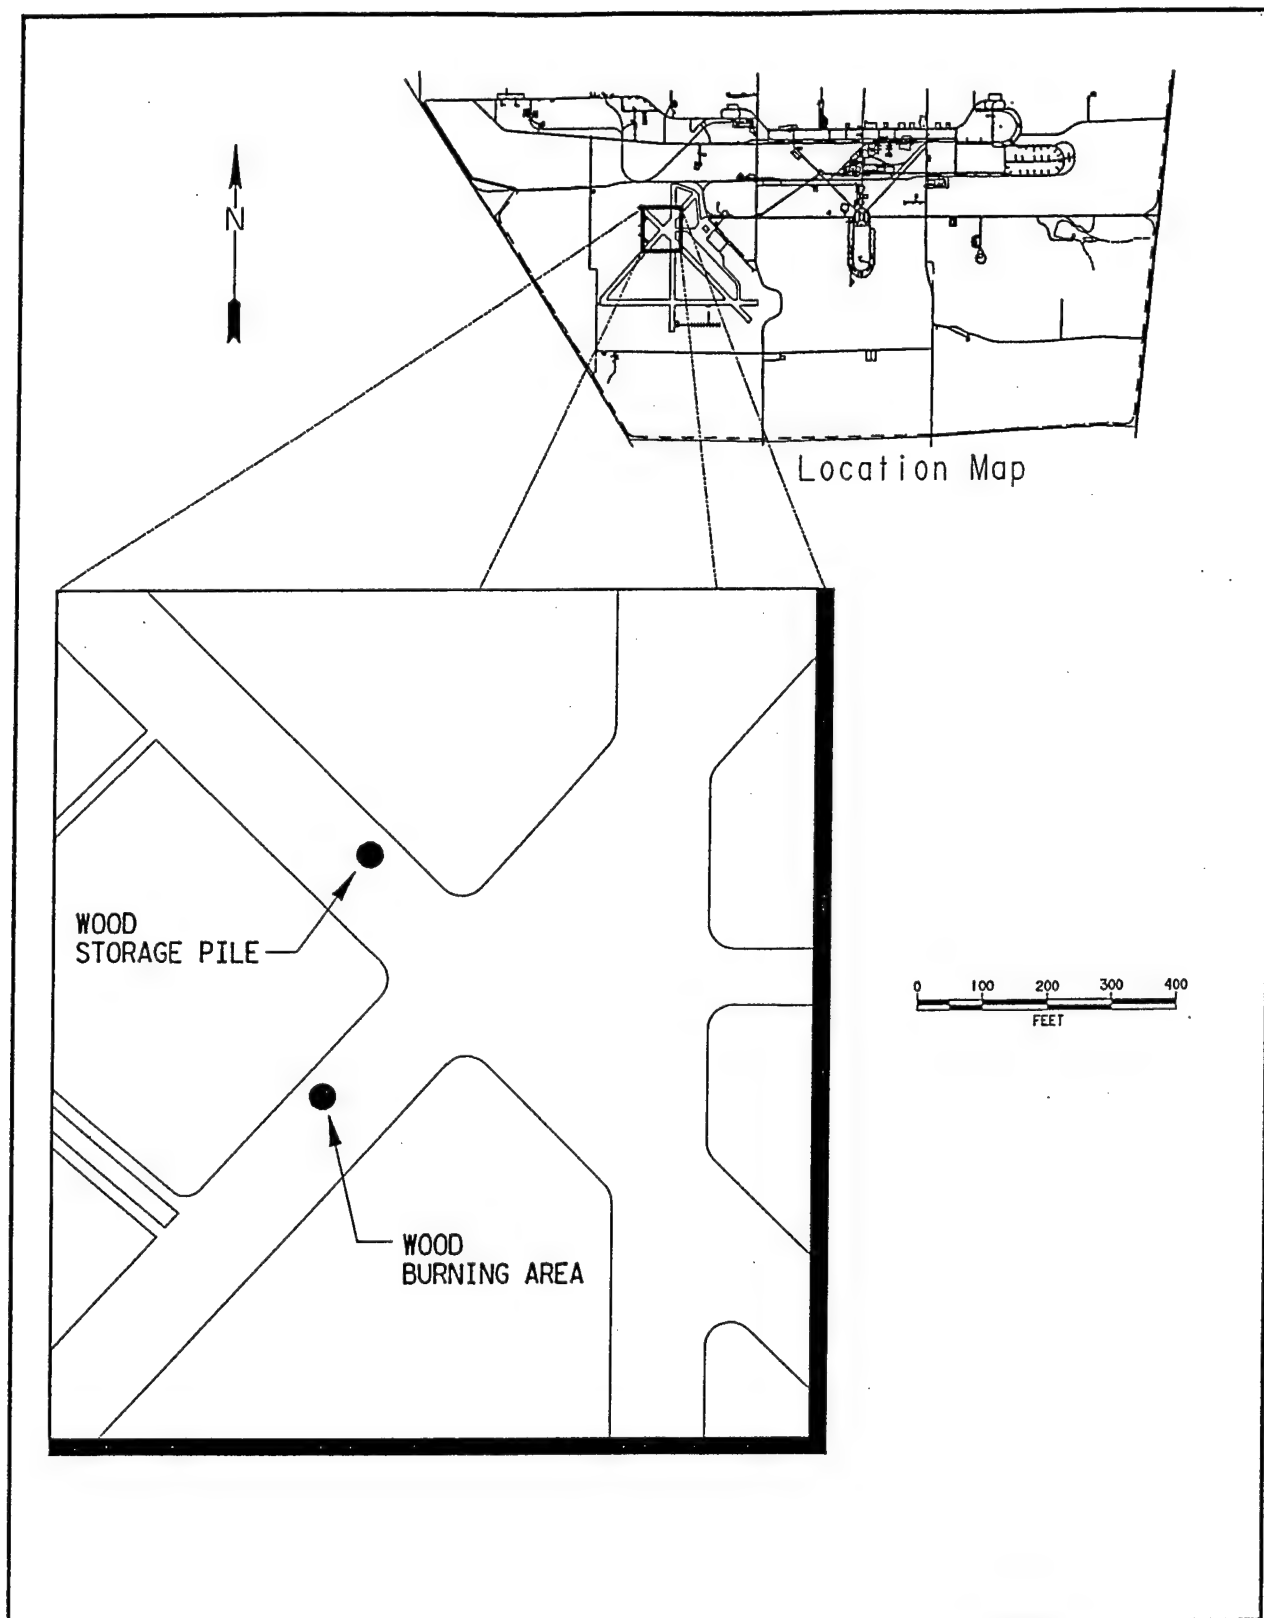
*Figure 8. Location of the Wood-Storage Pile and the Wood-Burning Area*

The Wood-Storage Pile consists of a 10-foot-high used wood stockpile covering approximately 300 square feet on an abandoned airport runway (see Figure 8). The stockpile consists of wood debris, plywood struts, boxes, pallets, and used crates that have been placed on the runway since about 1975. The second wood pile, referred to as the Wood-Burning Area, is an open-waste pile on the abandoned runway that received pentachlorophenol (PCP)-treated wood from about 1975 through 1990. The size of the pile varies as portions of it are periodically removed for off-site disposal; however, the size of the pile will be determined at the time of sampling and reported in the RI Report. A portion of the PCP-treated-wood pile was reportedly burned as a result of a lightning strike. It is suspected that residue PCP and dioxin may be present in areas where wood has been burned. Ash and other evidence indicates that previous burning of the wood pile may have occurred. Current practice for PCP-contaminated wood is to crush the wood and dispose of it in an off-site sanitary landfill.

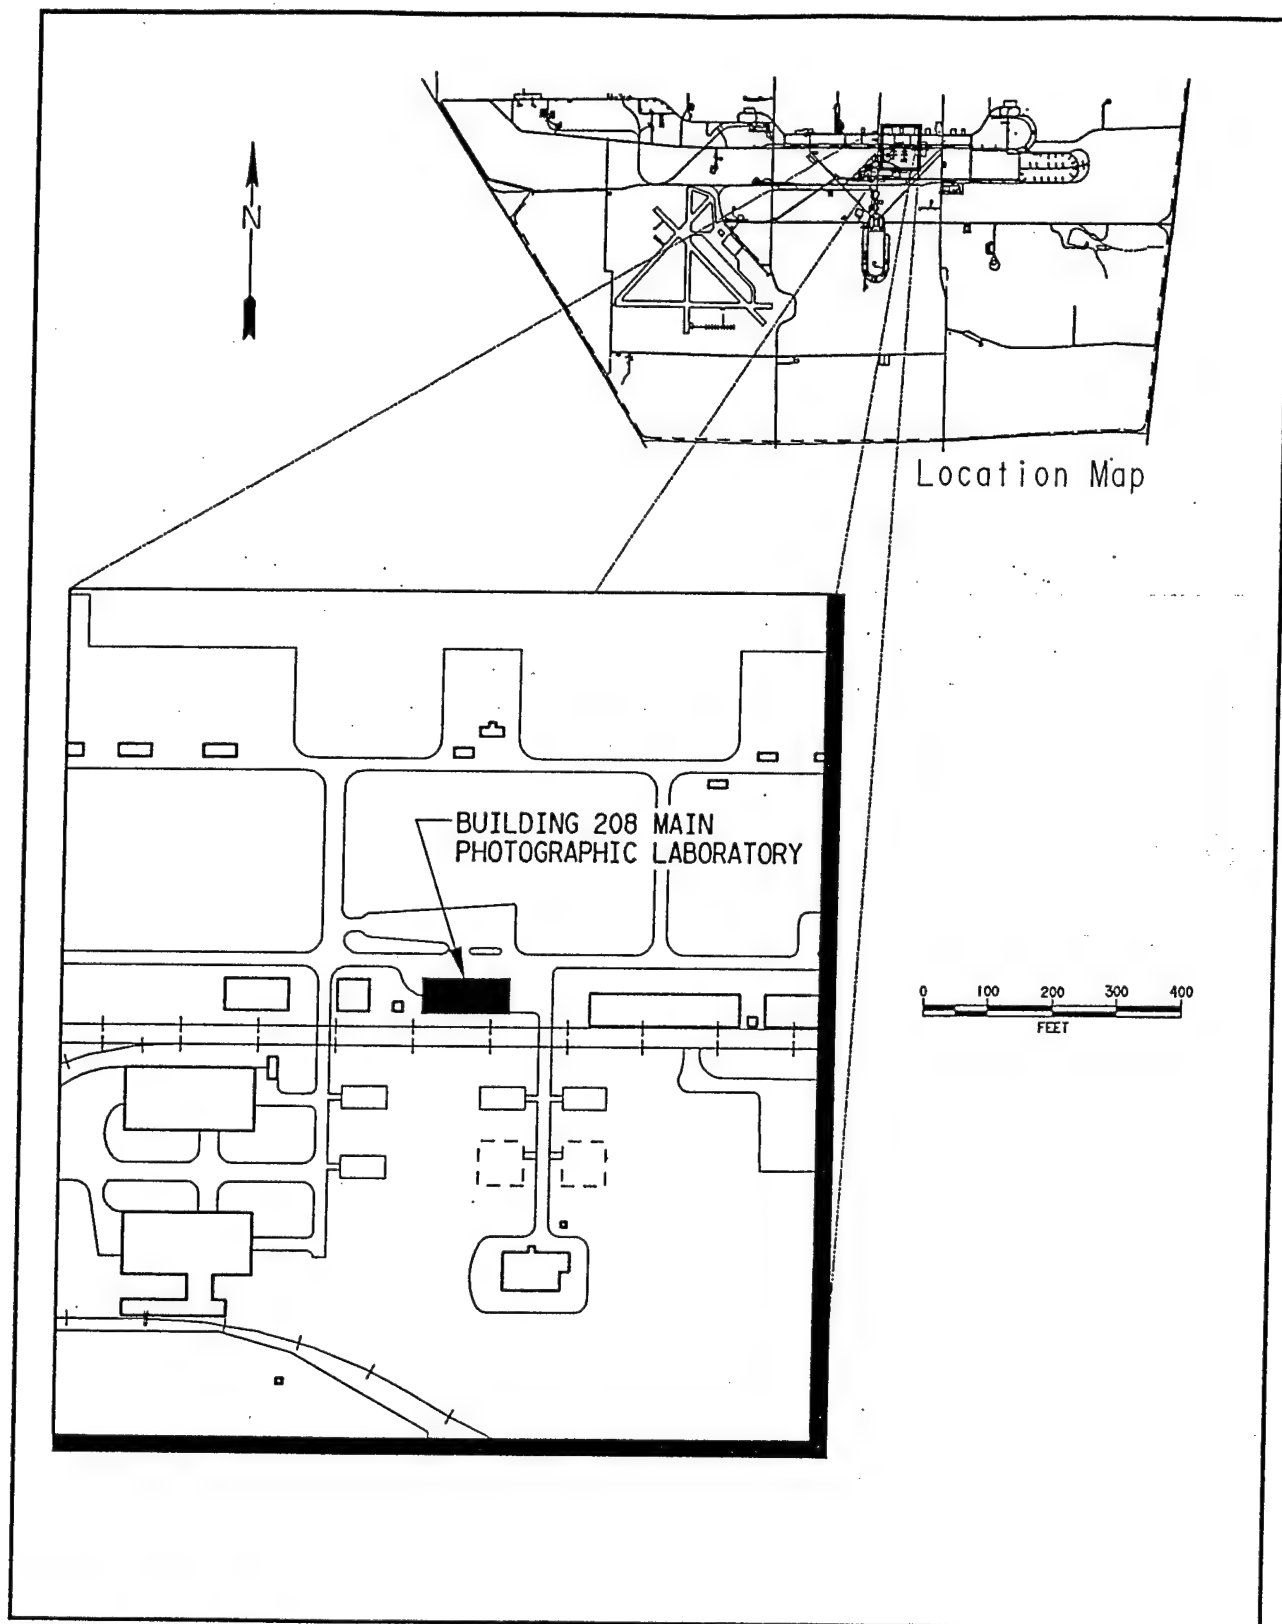
*Figure 10. Location of the Building 208 Main Photographic Laboratory*

Building 208 (see Figure 10) contains the main photographic laboratory at JPG. The building is a 4,929-square-foot laboratory used for processing, developing, and printing large

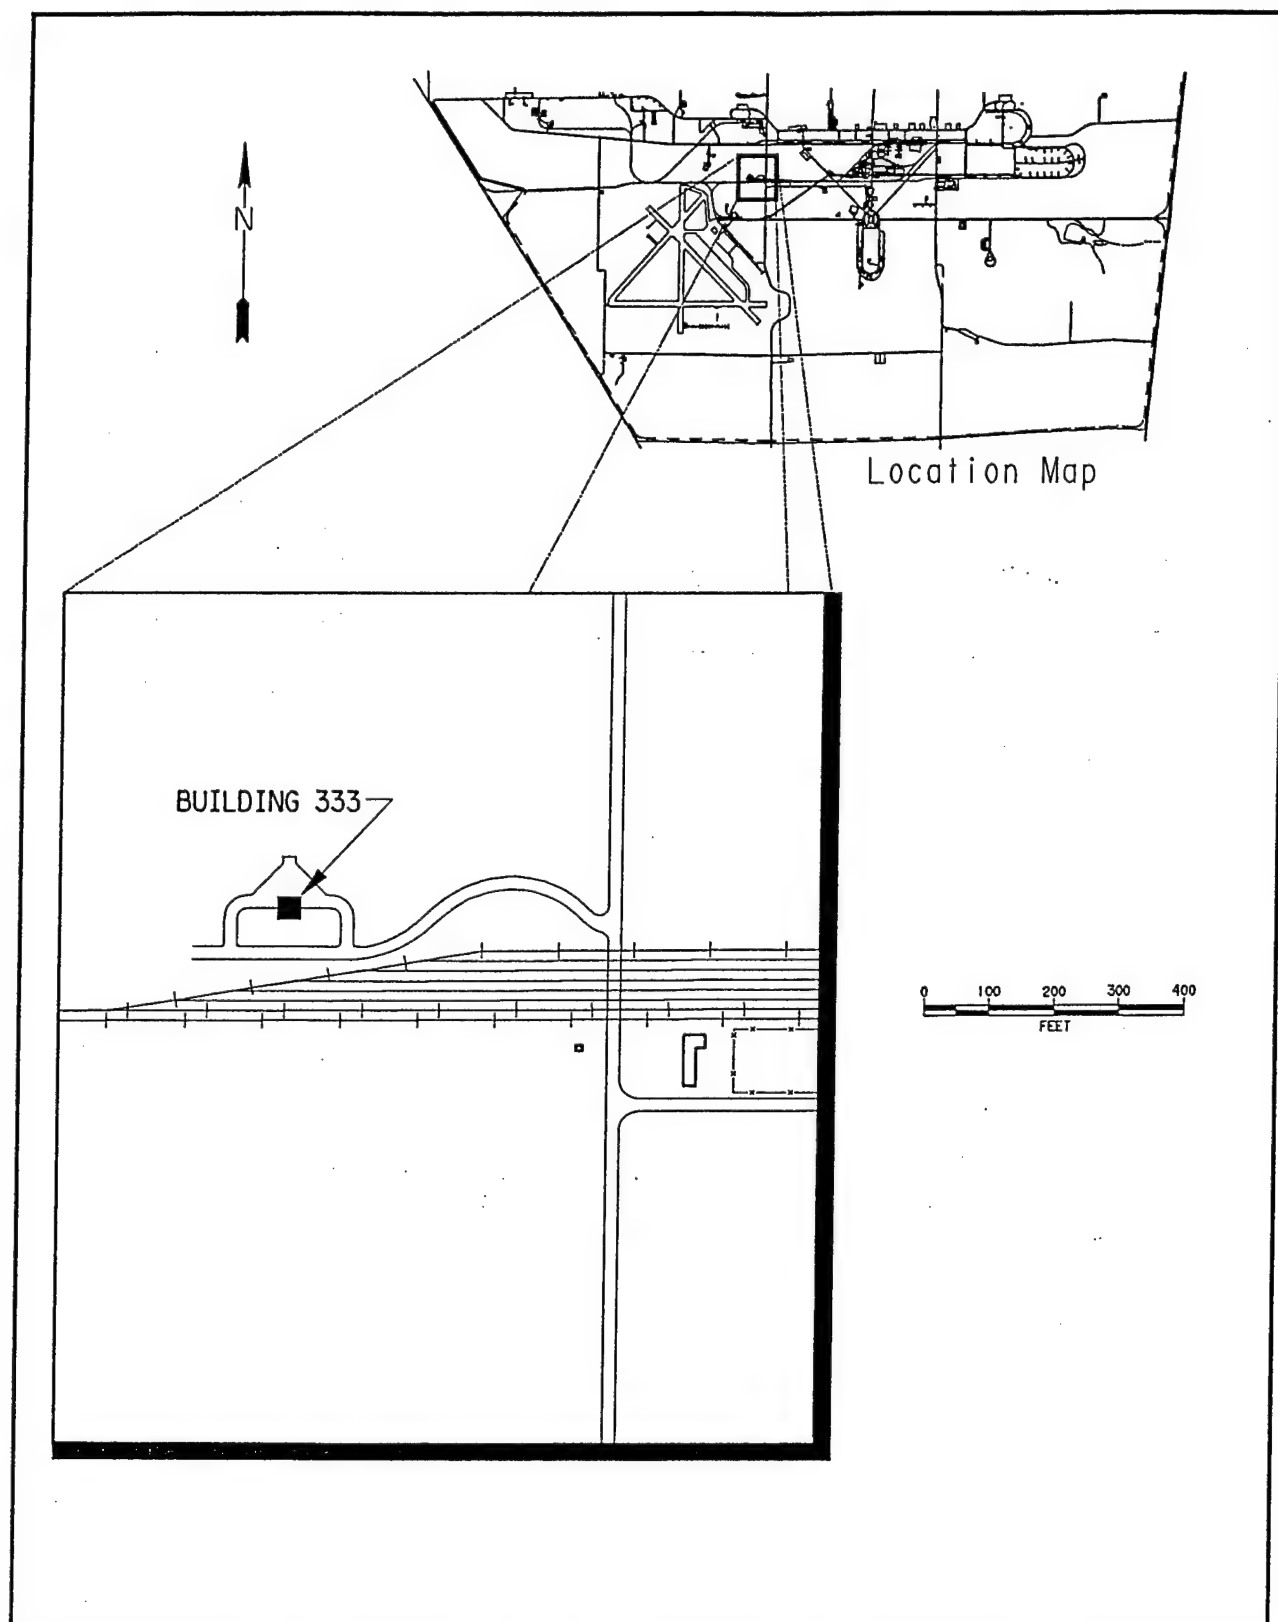
*Figure 11. Location of Building 333 Incinerator*

The Building 333 incinerator (see Figure 11), which has been in operation since 1978, is used to burn primarily paper and paper products. The incinerator is a fuel-oil-fired single-chamber unit with an afterburner. In 1988-89, polyurethane foams used as inert filler and wastes containing iron oxide were also incinerated. The resulting ash was characterized and properly disposed of. The test burn of these materials was unsuccessful and the practice was discontinued. Ash from the incinerator is placed in fiber drums and taken to the Gate 19 Landfill. Potential contaminants in the ash of the incinerator are primarily heavy metals.

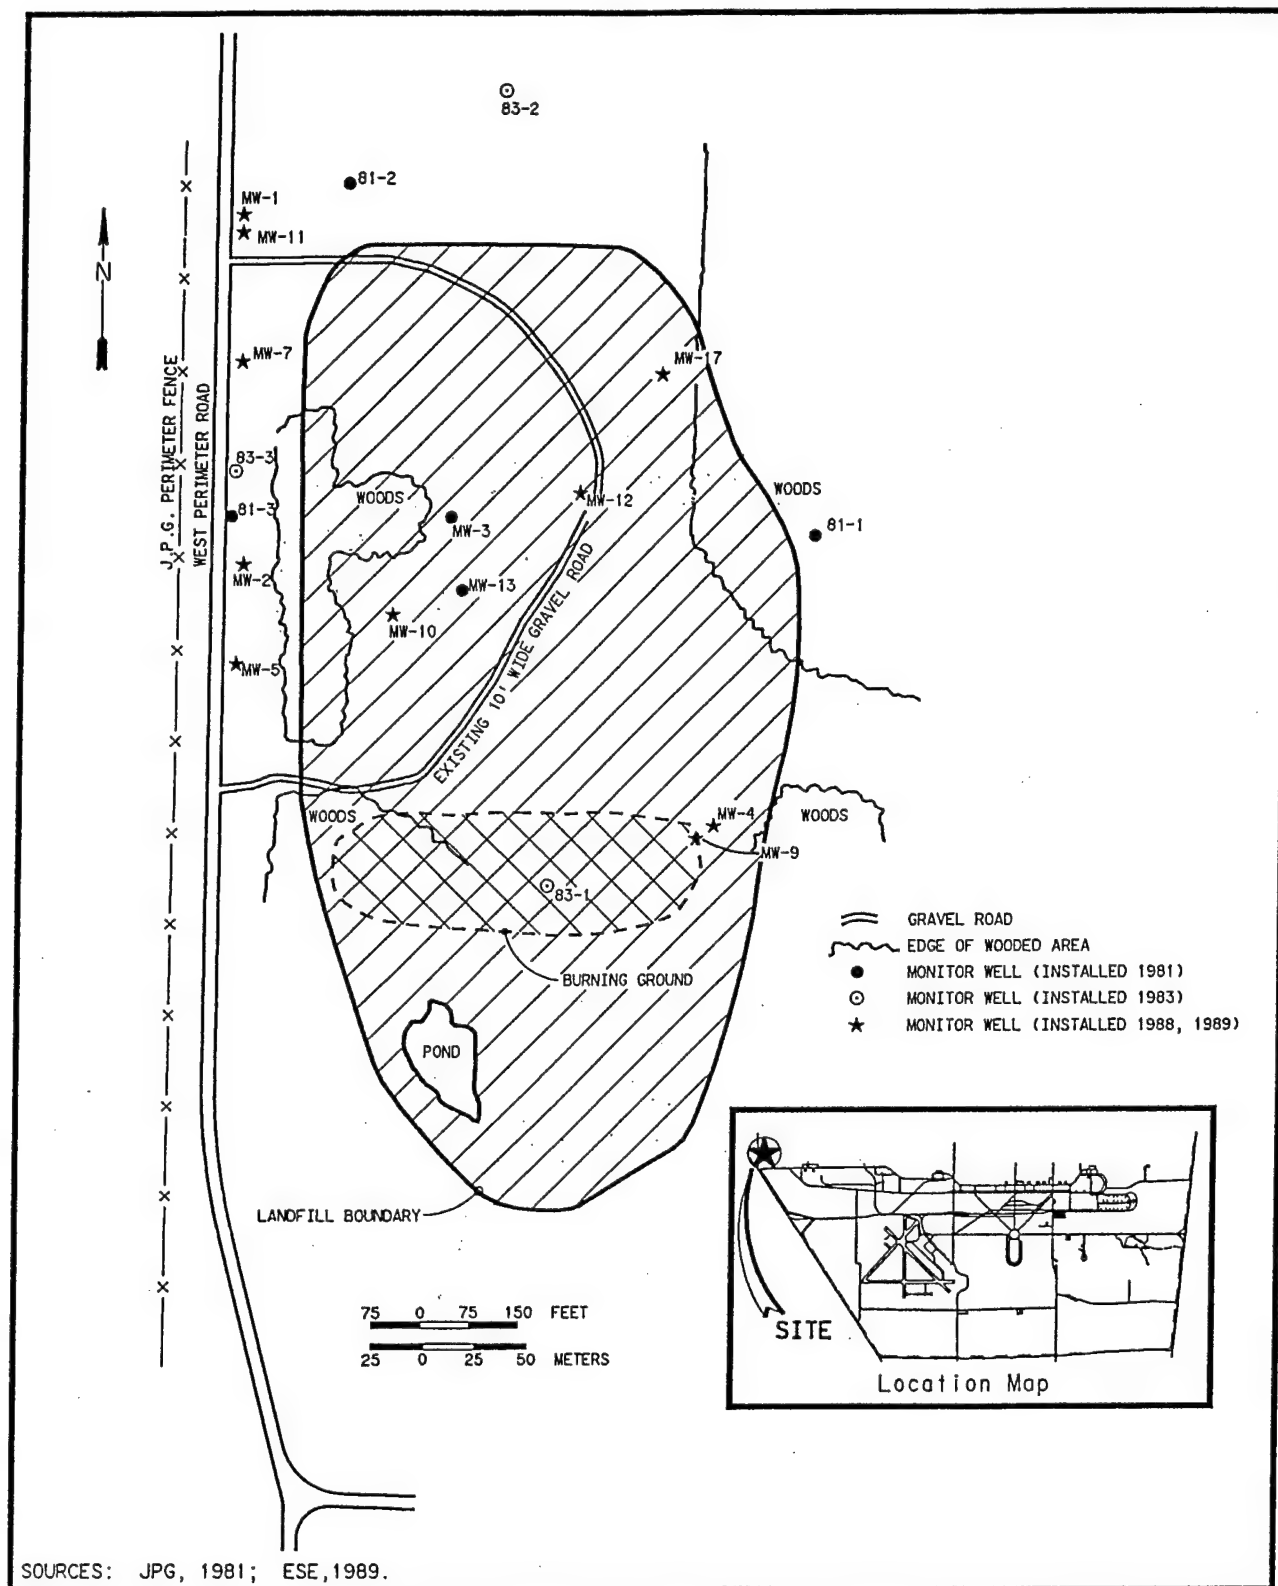
Figure 13. Location of the Gate 19 Landfill and Burning Ground South of the Gate 19 Landfill

Groundwater-monitoring wells are present at the Gate 19 Landfill (see Figure 13) immediately adjacent to the burning area. However, groundwater-flow information is insufficient to determine whether the open burning site is being adequately monitored. Monitoring wells located along the West Perimeter Road were intended to detect any contamination plume originating from the burning ground. To date, data from these wells indicate that no such contaminant plume exists. Additional groundwater-flow information is needed to more accurately define groundwater-flow directions in the area of the burning ground. A potential exists for off-site migration of contaminated groundwater to private drinking-water supplies. Monitoring data collected to date do not indicate that contamination of the groundwater has occurred. No data have been collected to determine if contaminants are present in surface and subsurface soils at the site.

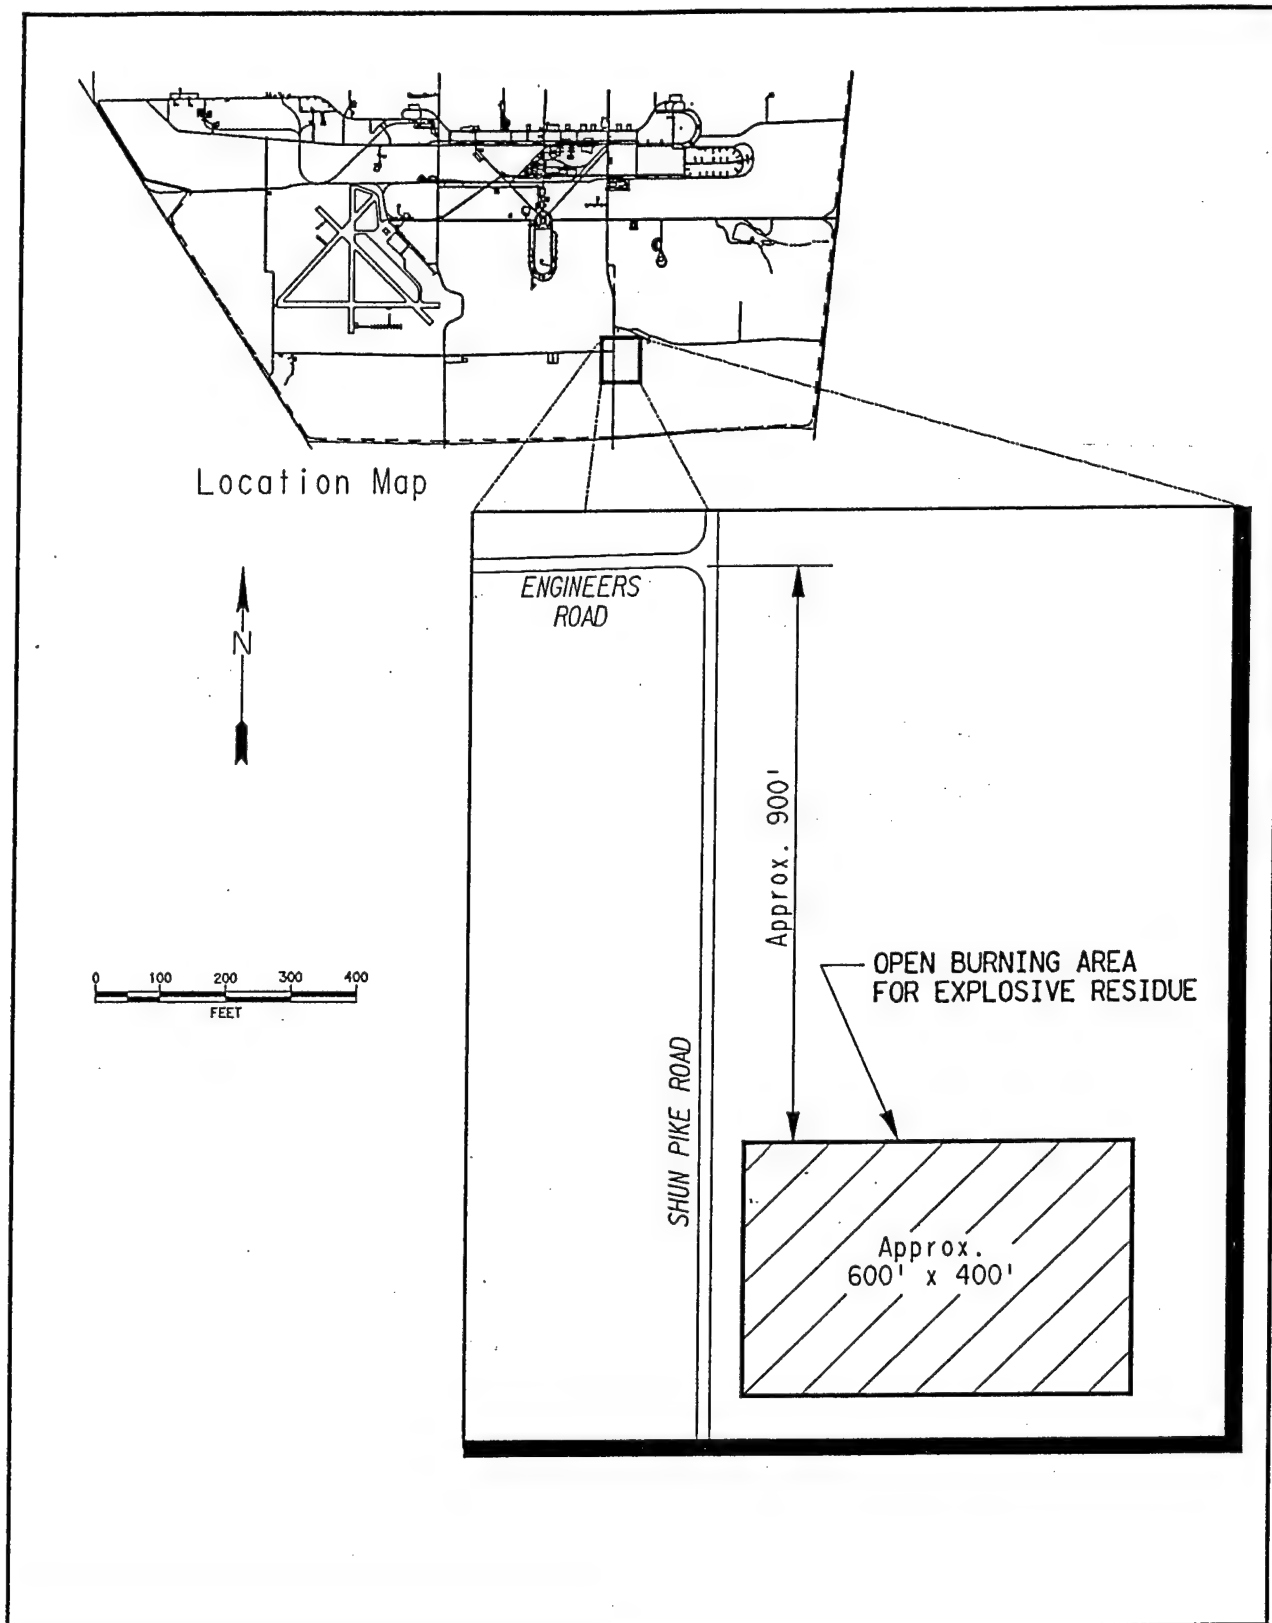
Figure 14. Location Map of Open Burning Area for Explosive Residue

This burning area is an active-powder burning area located in the southeast corner of the installation just east of Shun Pike Road (see Figure 14). The site has been used since the early 1950s to burn explosive waste and materials contaminated with explosive residues. Approximately 60,000 pounds per year have been open burned at this location. Currently, the burning is conducted in metal trays with locking covers, and the ash is being appropriately disposed of after analysis for hazardous characteristics. In the past, however, the open burning was performed on the ground. Analysis of ash in one report indicated the ash contained EPA toxic lead. This was believed to be the result of a failure to remove the
